AN INVESTIGATION OF SANDSTONE CONSOLIDATION METHOD
FOR THE NORTHERN GOPURA OF THE PHIMAI SANCTUARY,
A KHMER MONUMENT IN THAILAND

Nuanlak Watsantachad

A THESIS

Historic Preservation

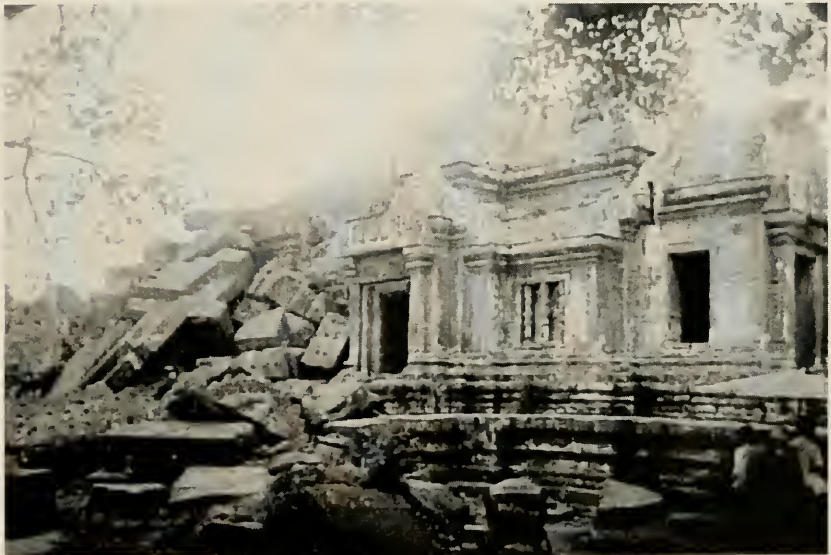
Figure 1.2: Collapse of the Viharn Sanctuary located in the border of Thailand and Cambodia. (July 2000)

Due to their age, many of these monuments were in a near state of collapse when the survey projects began in the early twentieth century. Only about 60% of the structures were standing while the other 40% had collapsed. Although the condition assessment of the stones—sandstone and laterite—used as building material was quite good, the construction was unstable. (See Figure 1.2)

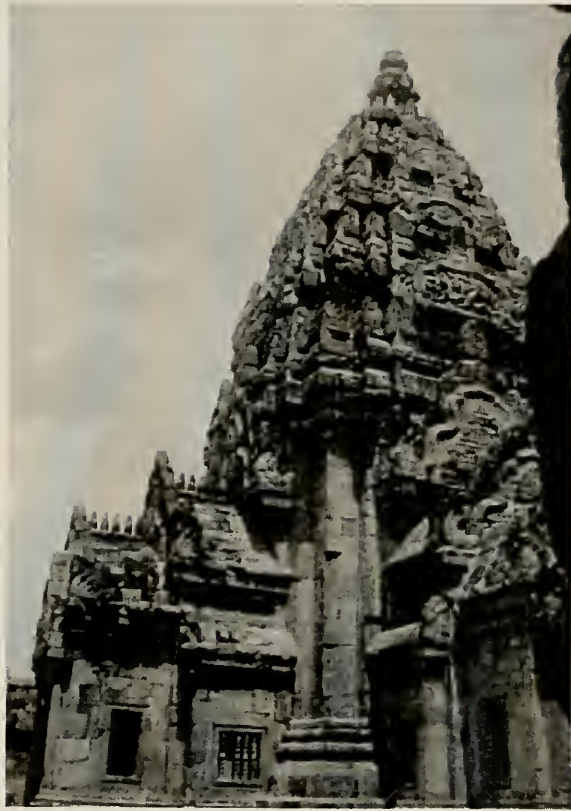
Figure 1.8: The Principle Tower after anastylosis restoration, 1964-1969.
(June 2000)

The siliceous sandstone principal tower was successfully restored with anastylosis more than 30 years ago. This was carried out between 1964 and 1969 at the request of the French Ambassador in Thailand, by B.P. Groslier, who was then director of Archaeological Research at the Ecole Francais d'Extreme-Orient and Curator of the Angkor Monuments. The sanctuary was reconstructed on a new reinforced concrete foundation with an inserted bracing structure inside the walls and under the vaults, and the tower was restored to its original height. (See Figure 1.8)

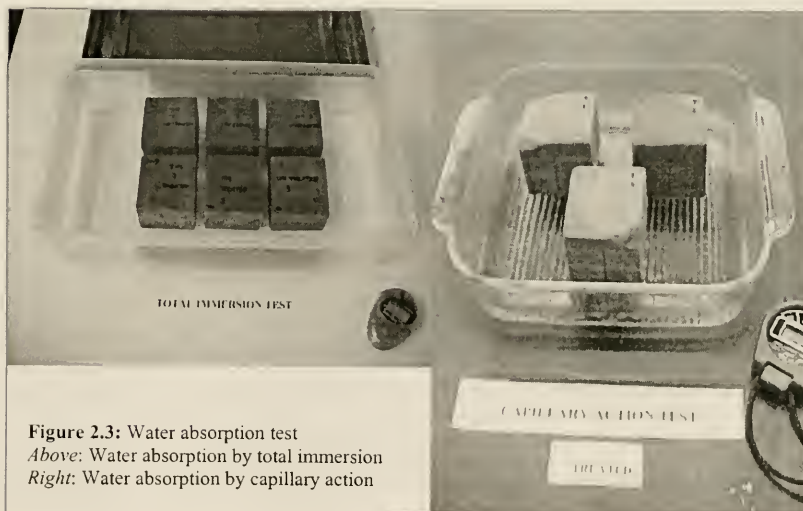
Figure 2.3: Water absorption test
Above: Water absorption by total immersion
Right: Water absorption by capillary action

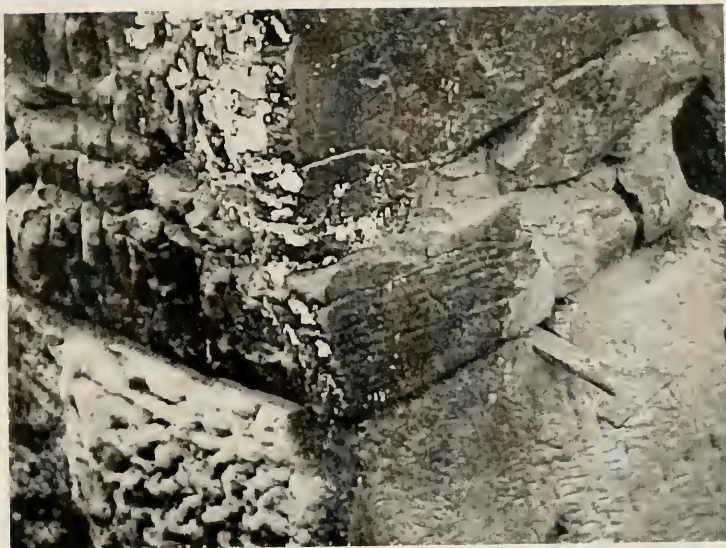
Figure 4.3: Crumbling and disaggregation of sandstone. The friability of the sandstone blocks of the Northern Gopura's wall is due to the loss of cementing material. (June 2000)

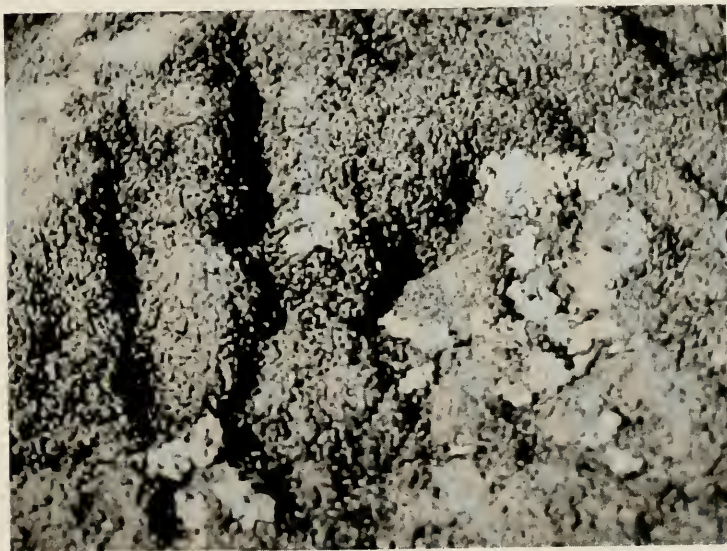
Figure 4.4: Lichen on sandstone surface. The biological growth indicates an evidence of dampness in the sandstone of the Northern Gopura's wall. (June 2000)

There are some evidences of biological growth depositing on the sandstone of the Northern Gopura of the Phimai Sanctuary. The types of biological growth and their effect, however, need further study in order to provide appropriate treatments to the stone, such as cleaning and protection, which will not be investigated and discussed in this thesis. (See Figure 4.4)

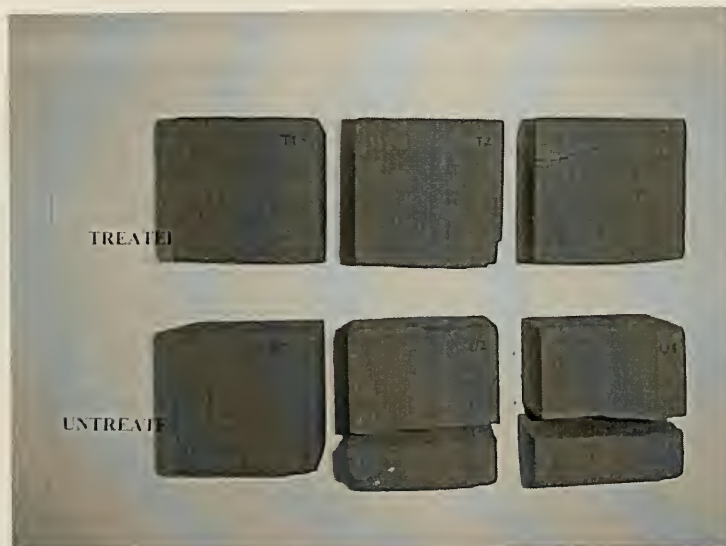
Figure 6.8: Untreated and treated stones after wet-dry cycling test
The untreated stone (#3) that had pre-existing cracks before being tested broke while the treated stone (#3) could resist the damage caused by wet-dry cycling. The untreated stone (#2) broke after the test although the pre-existing damage did not perform.
